# Manhole Inspection Summary

Manhole # S39AA\_028MH

Insp Date: **2/19/09 9:30 AM**

**Location** Address: **700 GREENMOUNT AVE**

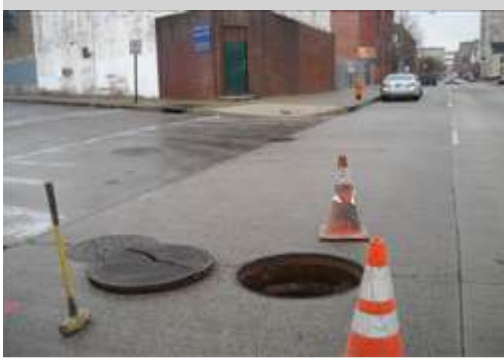
Location View

HAD TO BREAK OPEN LID WITH 16 LB MAUL

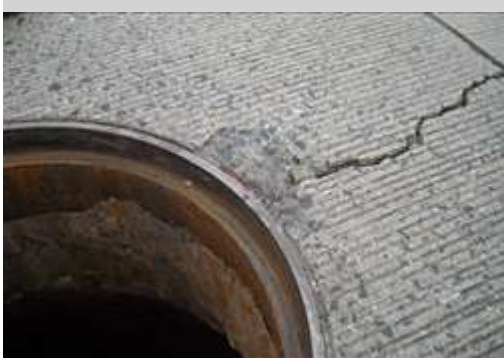
Miscellaneous

CRACKED CONCRETE AROUND FRAME IS ALLOWING INFILTRATION OF WATER

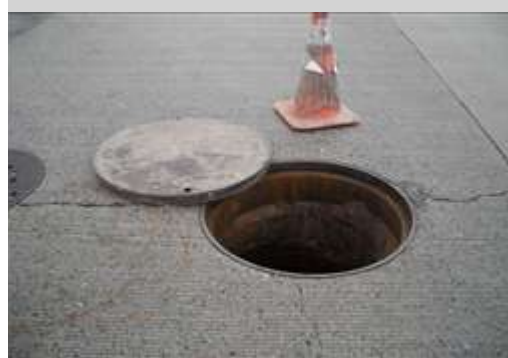
Comments **OBSERVED IN ROADWAY WITH CRACKED 30" LID. BROKE OPEN TO REMOVE AND REPLACED WITH NEW 30" SANITARY LID BY REI/DRAYCO. INSPECTION COMPLETE.**

ORIGINAL 30" SANITARY LID

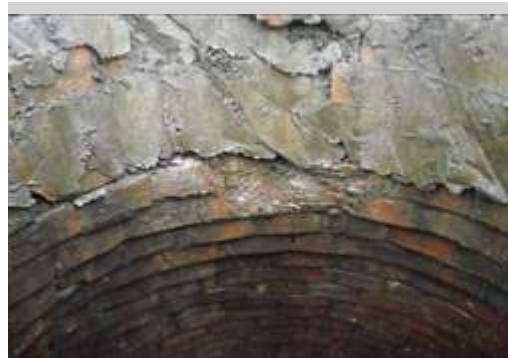
BELIEVE THIS IS A SOURCE OF INFILTRATION FROM OUTSIDE FRAME

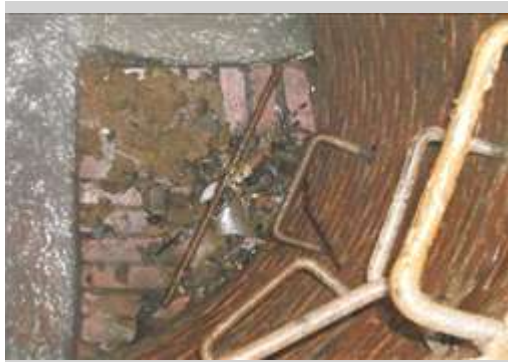
Defect 2

Condition: ☐ Sound ☐ Cracked ☐ Root Intrusion ☐ Deteriorated ☐ Leaks ☒ **Debris**

DEBRIS ON BENCH

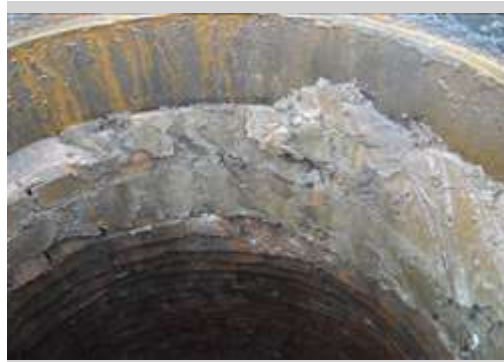
Defect 1

Condition: ☐ Sound ☒ **Cracked** ☐ Root Intrusion ☐ Loose Brick ☐ Deteriorated

Infiltration: ☐ None ☒ **Joint** ☐ Cracks ☐ Mortar ☐ Roots ☒ **Wall**

FRAME ADJUSTMENT 12" HAS SOME CRACKS

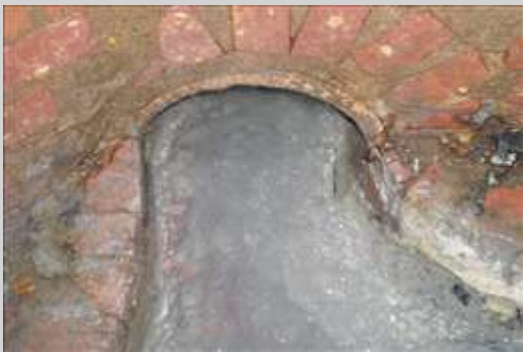
12 O'Clock Outflow

Pipe Height: **9.6** (in.) Rod and Bar (Angled)  
Pipe Material: **Clay** ☐ Pipe Lined  
Invert Depth: **10.30** (ft.) Flow Characteristics: **Fast**  
Deposits: ☐ None ☐ Mud ☐ Sludge ☐ Debris ☒ **Grease**  
Silt Depth: **3** (in.) Deposits Extent: **Medium**  
Infiltration: **None** Pipe Seal Cond: **Sound**

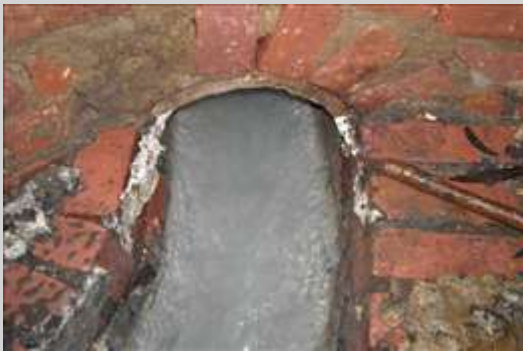
3 O'Clock Inflow

Pipe Height: **9.6** (in.) Rod and Bar (Angled)  
Pipe Material: **Clay** ☐ Pipe Lined  
Invert Depth: **10.18** (ft.) Flow Characteristics: **Fast**  
Deposits: ☐ None ☐ Mud ☐ Sludge ☐ Debris ☒ **Grease**  
Silt Depth: **2** (in.) Deposits Extent: **Light**  
Infiltration: **None** Pipe Seal Cond: **Sound**

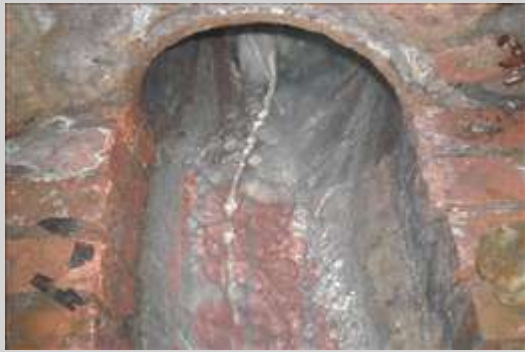
6 O'Clock Inflow

Deposits: ☐ None ☐ Mud ☐ Sludge ☐ Debris ☒ Grease

Silt Depth: **1** (in.) Deposits Extent: **Light**
